Do you have asbestos at home?

Typical locations for the most common asbestos-containing materials around the home.

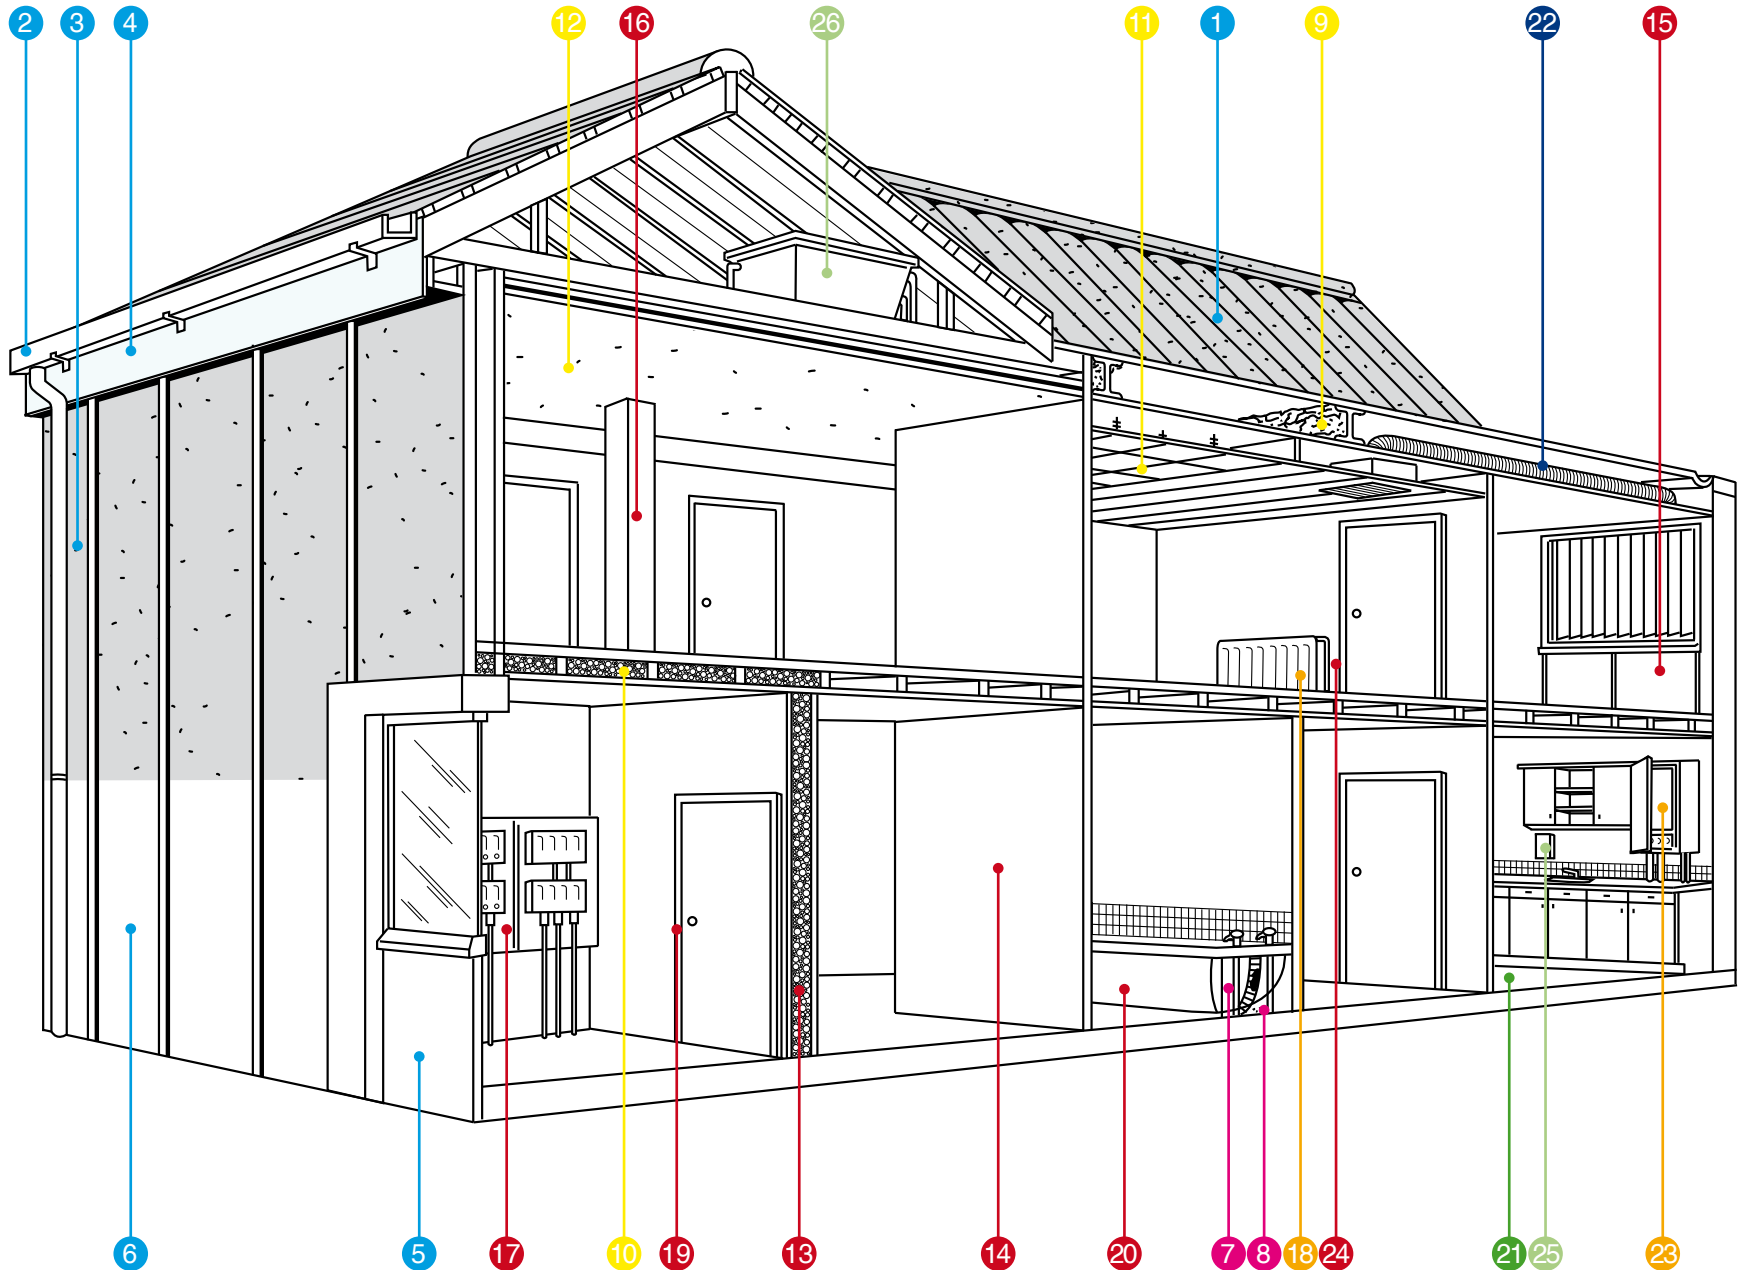
- Roof and exterior walls**
 - 1. Roof sheets and tiles
 - 2. Guttering and drainpipe
 - 3. Wall cladding
 - 4. Fascia boards
 - 5. Panel beneath window
 - 6. Coating to metal wall cladding

- Pipework**
 - 7. Lagging on pipework
 - 8. Damaged lagging and associated debris
- Ceilings**
 - 9. Spray coating to ceiling, walls, beams/columns
 - 10. Loose asbestos in ceiling/floor cavity

- 11. Tiles, slats, canopies and firebreaks above ceilings
 - 12. Textured coatings and paints
- Interior walls/panels**
 - 13. Loose asbestos inside partition walls

- 14. Partition walls
 - 15. Panel beneath window
 - 16. Panelling to vertical and horizontal beams
 - 17. Panel behind electrical equipment
 - 18. Panel behind/under heater

- 19. Panel on (or inside) fire door
 - 20. Bath panel
- Floor materials**
 - 21. Floor tiles, linoleum and paper backing, lining to suspended floor
- Air handling systems**

- 22. Lagging
- Domestic appliances**
 - 23. Gaskets, rope seals and panels in domestic boilers
 - 24. Insulating blocks, panels, paper, string etc. in domestic heater

- Other**
 - 25. Fire blanket
 - 26. Water tank
